APPLYING THE ISHIKAWA DIAGRAM IN THE PROCESS OF IMPROVING THE PRODUCTION OF DRIVE HALF-SHAFTS

The company that will be presented in this analysis produces half-shafts for various types of cars and constantly analyzes, verifies, and undertakes corrective and preventative action to remedy the occurring inconsistencies. For this purpose, the company uses, among other means, various quality tools. The object of the following research is the application of the Ishikawa diagram in the process of improving the half-shaft production.

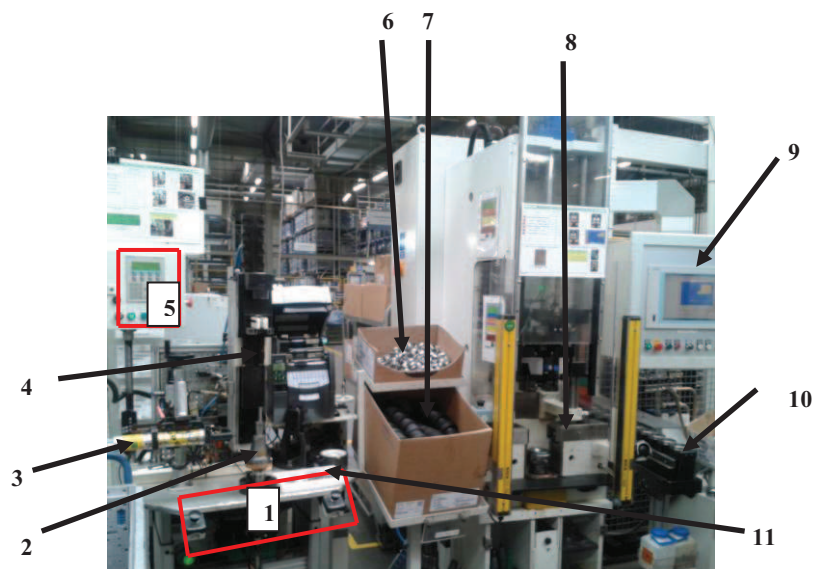
following components: (2) band / bands, (3) housing, under which a sufficient amount of grease can be found, (4) labels, (5) joint located on the wheel's side, and (6) tulip. The left side of the drive half-shaft is located on the wheel's side, while the right side is located on the gearbox' side. Preliminary analysis of the production process showed that a falling band located on the side of the wheel causes the problem. The problem occurred at the work stand of the first assembly line operator (Figure 2.2).

Fig. 2.2. The work stand of the first assembly line operator.

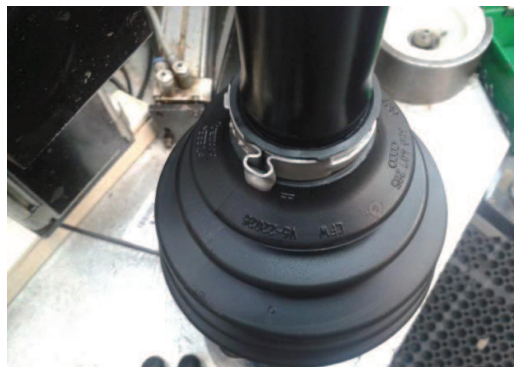
Fig. 2.3. Band installed properly.

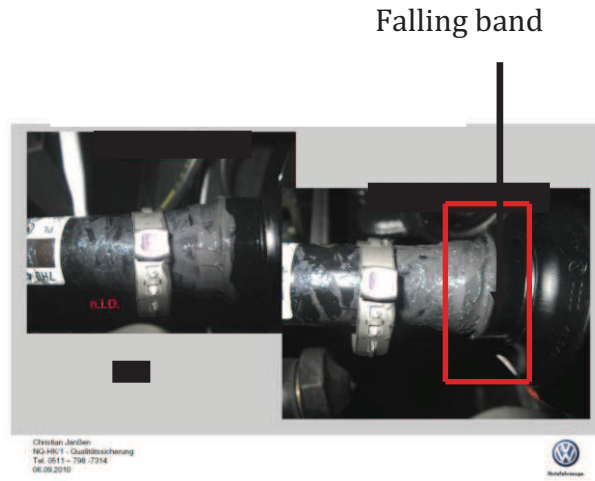
The client received the half-shafts, which were mounted in the vehicle. The issue concerning them was that the small bands located on the wheel's side were sliding off automatically from the housing of the drive shaft as a result of rotation, the result of this situation was the unsealing as well as leaking of grease- that could have been the cause of bearing seizure. In the picture (Figure 2.3) the band is located in the correct spot on the housing, while in the picture (Figure 2.4) the band, on the wheel's side, is sliding off

Fig. 2.4. Falling band located on the wheel's side.

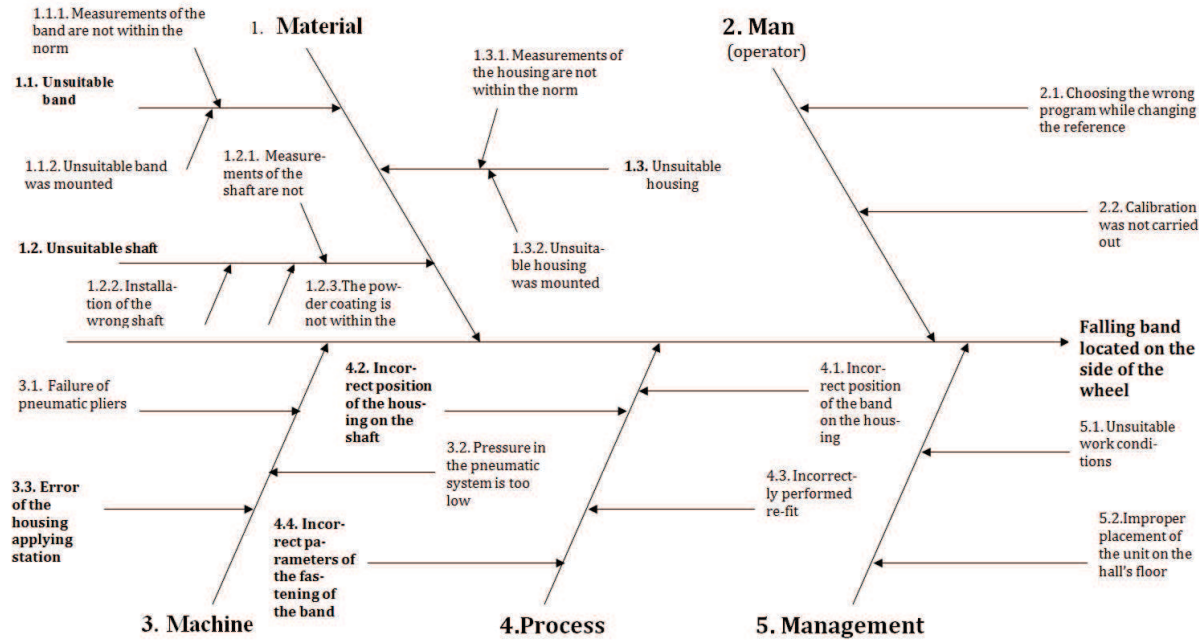
In the Figure 2.5 the non-compliance, that is the falling band located on the drive half-shaft on the wheel's side, is presented in the form of the Ishikawa diagram.

Fig. 2.5. Ishikawa Diagram.

Based on the analysis of the cause - effect Ishikawa diagram three causes were selected that had the greatest influence on the issue being analyzed and need to be improved. These are: 1) Error of the housing applying station; 2) Incorrect position of the housing on the shaft; 3) Incorrect parameters of the band's fastening.

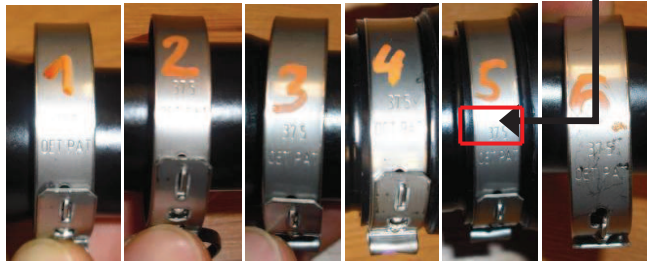
<p>1. Category of causes: the material</p>
<p>1.1. Cause: unsuitable band</p>
<p>1.1.1. Sub-cause: the dimensions of the band do not meet the standards. To verify this cause the following measurements were taken: - thickness of the band, - width of the band, - firmness of the band, - gaps of the band's fastening. After taking the above measurements it was concluded that the size of the band is suitable and meets the requirements of the company</p>
<p>1.1.2. Sub-cause: wrong band was installed The study shows that all of the bands, produced on the day when the complaint was issued, measured 37.5 mm (Fig. 2.6), which is in line with technological documentation. Therefore, this sub-cause does not have any effect on the analyzed problem.</p> <div style="text-align: right; margin-right: 50px;"> <p>Dimen- sions of the band</p> </div>

<p style="text-align: center;">Fig. 2.6. Band measuring 37.5 mm.</p> <p><i>Source: personal study based on the materials acquired from the company</i></p>

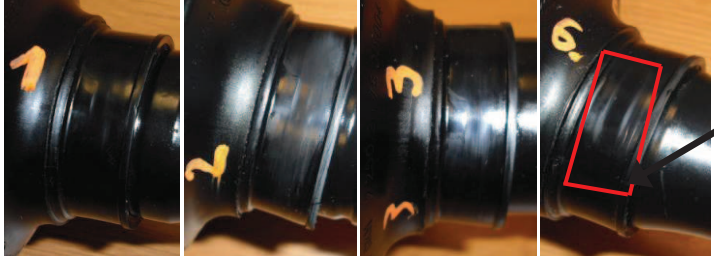
<p>4. Category of causes: technological process</p>
<p>4.1. Cause: The incorrect position of band on the housing. Based on the research carried out in the company it can be concluded that the marks on the housing of the defective parts indicate that the band was tightened in the correct position, the proof of this are the images presented in Figure 2.9. Therefore, this cause can be eliminated.</p>
<div style="display: flex; align-items: center;">

<div style="margin-left: 10px;"> <p>The place where the band was located on the housing</p> </div> </div>
<p style="text-align: center;">Fig. 2.9. The place where the band was located on the housing. Source: personal study based on the materials acquired from the company</p>

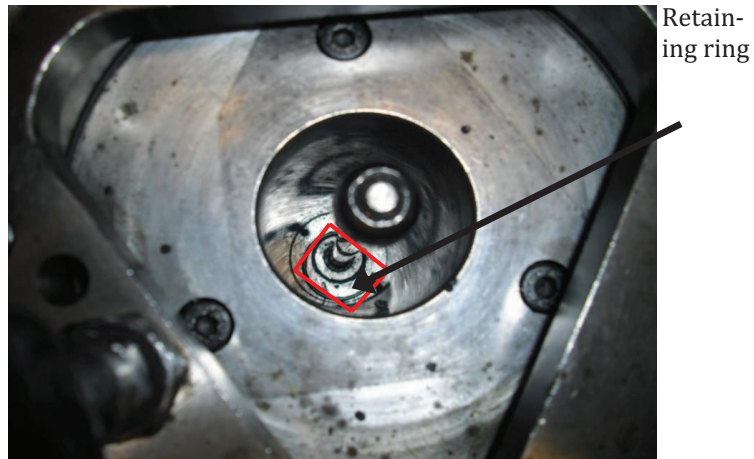
This may be a potential cause to the problem, as there is a risk of the retaining ring (element used in the manufacturing of a shaft) getting into the assembly head(on which a housing with a band is placed, and then using the housing applying station the shaft is pushed into the housing) causing the housing to be in the incorrect position during assembly.

The Figure 2.10 presents the assembly head inside of which the retaining ring is located.

Fig. 2.10. Assembly head.

2. Incorrect position of the housing on the shaft. A ban that concerns placing the bands loosely on the station's table should be issued, as well as installation of the dish to keep the bands in that would have its designated place. Moreover, an additional confirmation of the correct position of the housing on the shaft can be introduced using a special chip placed in the head and connected to the control panel. If the housing is installed in the wrong position on the shaft then the station will not start and you will see an information about irregularity appear.

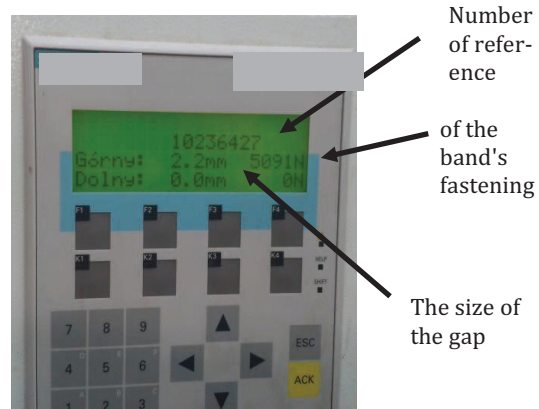
This unit (the control panel of pneumatic pliers), which is used to change parameters while the work is being performed, is not secure, which is equivalent to the fact that everyone has access to it and, therefore, there is a potential risk of changes in the parameters introduced by the operator. This cause may have had an influence on the issue being analyzed.

Figure 2.11 presents the device, which can be used to change the parameters.

Fig. 2.11. The control panel.

3. Incorrect parameters of the band's fastening it is necessary to restrict the access to the parameters of bands' fastening by introducing an additional security measures in the form of card readers in the audited company - only authorized employees will have access to the parameters, namely, the leaders, the station leader, process engineers and automation engineers. In addition, the operator should measure the gaps of every band that has been mounted, using a gap gauge.
