QUALITY INFLUENCE OF WELD SURFACE POST TREATMENT ON THE FATIGUE RESISTANCE OF WELD JOINTS

Abstract: This work deals with fatigue testing of the EN S355 structural steel weld joint. The weld was manufactured by the MIG welding technology and as the filler material was used the G3Si1 wire. The fatigue tests were carried out in the rotating bending mode on the specimens manufactured from the welded joint of the S355 steel. The main aim was to evaluate the fatigue endurance of the weld material and for this reason were used machined axis symmetrical specimens to remove the notch effect of the weld shape. In order to increase the fatigue endurance of the weld, the Nd-YAG laser was used for laser shock peening (LSP) of specimens surfaces, which lead to removing of the weld defects but in overall caused the laser bead on the smooth specimen has behaved as the notch and lead to decreasing of the fatigue endurance. Obtained results of fatigue tests are compared, discussed and supported by correlation with results of additional experiments, e.g. identification of incurred structures after the laser shock peening by the metallographic observations and micro-hardness tests.

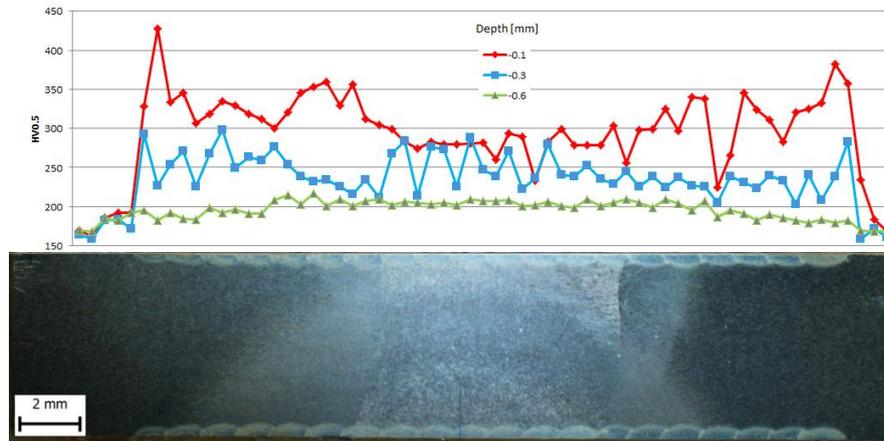
Given that it was necessary to carry out other tests, that would indicate the source of premature crack initiation, one of the backup specimen was cut in the middle longitudinal direction, as can be seen in the lower part of the Fig. 12.4. The surface was metallographically prepared and

etched to reveal the microstructure. Results provided in Fig. 12.4 include welded joint macro, metallographic analysis of incurred structures and their hardness measurement in the longitudinal direction at three levels related to the distance from the original surface of the specimen. Macro observation showed no impermissible welded joints defects, problems in the laser shock peening process or geometrical problem that would cause the formation of crack initiation on the smooth specimen. Metallographic observations have shown the ferritic-pearlite fine grain rolled structure of the S355 steel without any non-permissible impurities or defects. In the Figures 12.5, 12.6 and 12.7 there are shown microstructures in the starting point, middle point and ending point of surface laser treatment. The weld contain fine ferritic-pearlite annealed structure incurred after annealing from heat input caused by the weld covering layers, which were machined out during the specimen manufacturing. Structure in the LSP inflected zone can be identified as the fine bainite which is also confirmed by the hardness results. The hardness states are represented by three curves on the different levels as was mentioned above. Measuring was carried out in the 0.1, 0.3 and in the 0.6 mm depths by the relative distance from the surface. In this point the only one explanation why the premature crack initiation has begun is the rapid increase of the hardness between the base material – LSP interface. This increase is 250 % from average 170 HV of base material, up to the 430 HV in the first laser shock peening bead, while other beads have been annealed by each other up to the last one, where the hardness reached the 382 HV because heat input from process increased the internal temperature of specimen and prevent as well amount of heat output for hardening as when the process has begun. Very low hardness declaim can be observed in the beginning and in the end of the process, where in the 0.3 mm depth hardness dropped approximately by the 20 HV.

Fig. 12.4. Microhardness profile of the weld surface layer treated by laser
 Source: own research

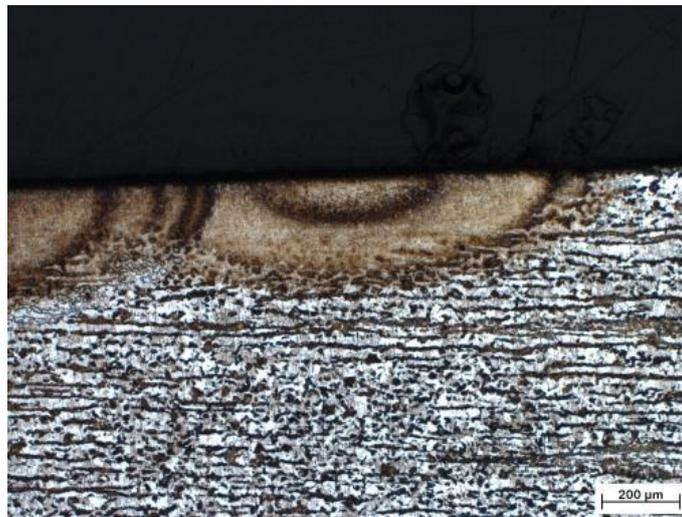
Fig. 12.5. Microstructure in the starting point of the laser surface treatment of the weld joint

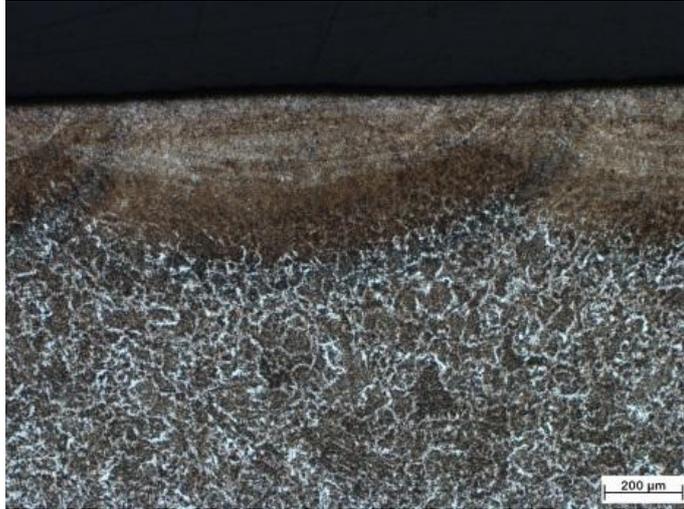
Fig. 12.6. Microstructure in the middle of the laser surface treated weld joint
Source: own research

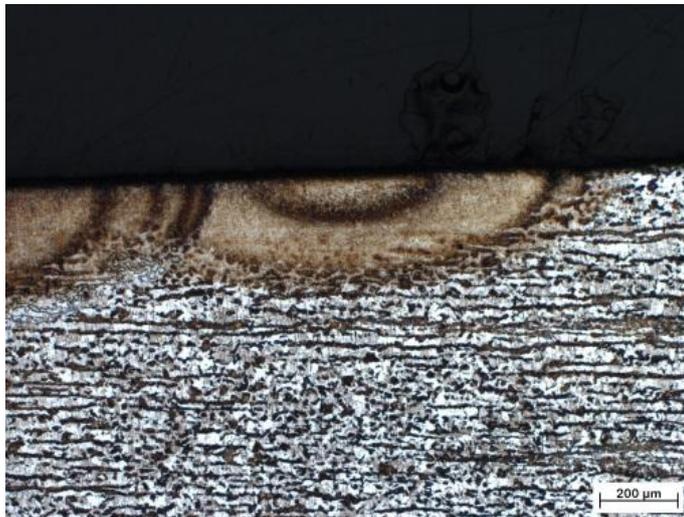
Fig. 12.7. Microstructure in the ending point of the laser surface treatment of weld joint
