Ali ATEŞ

Duzce University
Faculty of Technology Civil Engineering Department
Konuralp Campus 81620 Düzce-TURKEY

EVALUATION OF SEISMIC AMPLIFICATION ON EARTHQUAKE DAMAGES OF REINFORCED CONCRETE STRUCTURES DUE TO 12 NOVEMBER DUZCE EARTHQUAKE 1999 IN DUZCE, TURKEY

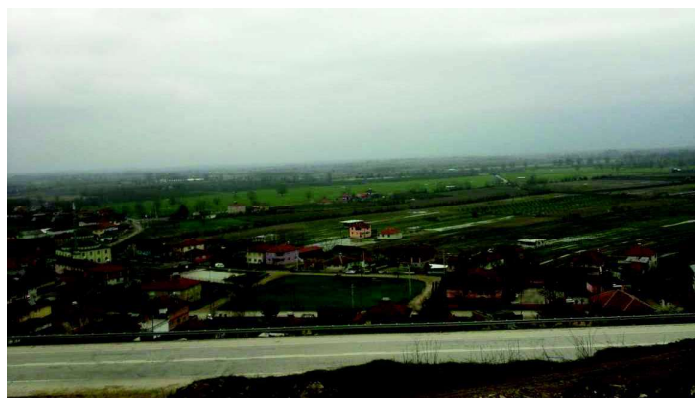
Fig. 1. View of the study area

Study area is just situated between Ankara and Istanbul; Ankara is 240km away to the East and Istanbul is 228km away to the West. The road of D-100 passes through Duzce and TEM Highway passes around it. Duzce is placed into the plateau of The West Black sea coast. The city is surrounded to the West by Sakarya, to the Northeast by Zonguldak and to the East by Bolu. The distance from East to West is 23 km and from North to South is 20 km. The city of Duzce is situated in the middle of the plain on a pressure ridge-type hill and is probably tectonically controlled (Fig. 1).

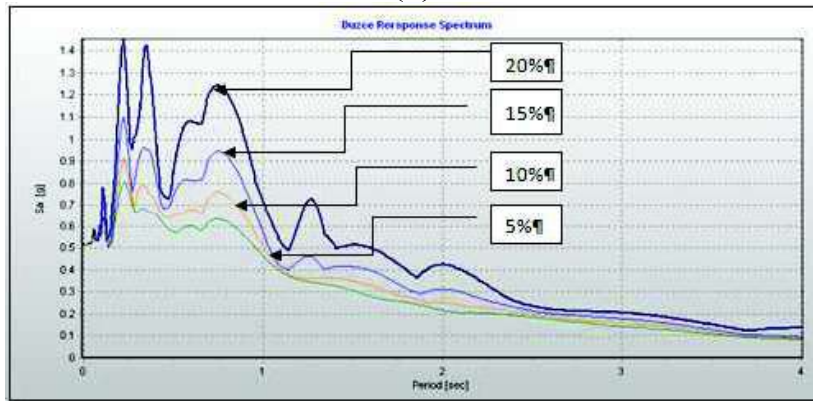
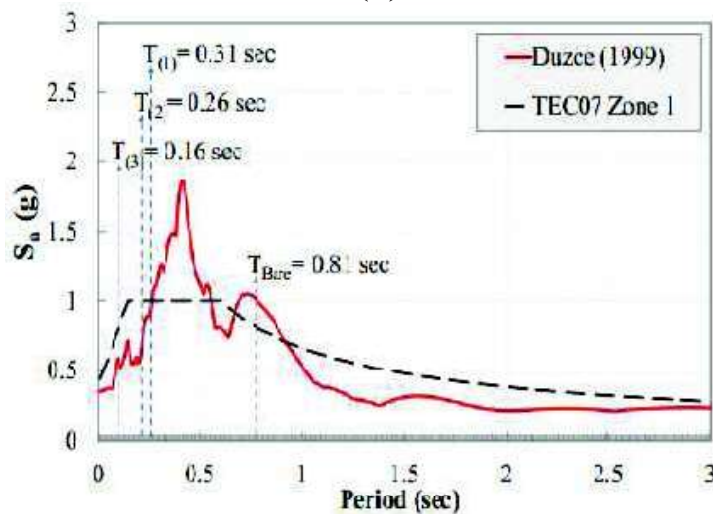
Fig.6.(a). Response spectra at the surface for soil profiles (West and South component, Metererological Station Duzce record of August 17 and November 12, 1999, $a_{max}=0.51g$)

Fig.6. (b) Response spectra at the surface for soil profiles (West and South component, Metererological Station Duzce record of August 17 and November 12, 1999, $a_{max}=0.51g$) [Akpınar and Binici, 2013]

If it looked at the Figure 6, it compares linear elastic response spectra of the recorded accelerograms with the design spectrum in the Turkish Seismic Code [2007] specified for Seismic Zone 1 (most severe) and medium dense deep alluvial soils, having a 10% probability of exceedence in 50 years. Due to the fact that the building stock in the Duzce city consists of structures less than 4 stories, hence having approximate fundamental vibration periods of 0.16-0.8 seconds. Thus, structural damage is certainly expected in Düzce during the earthquake.

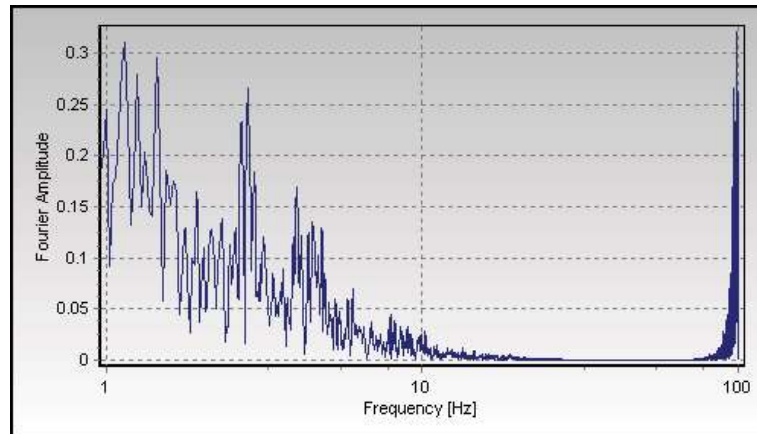
Fig.9. Response spectra at the surface for soil profiles (Meteorological Station Duzce record of November 12, 1999, $a_{\max}=0.51g$)

The amplification spectra of the surface motion have been determined for the study area soils are shown in Fig 9. Here, when it can be observed that when the peak ground acceleration of the bedrock motion is 0.04 g, and there can be seen distinct peaks at periods $T_1=3$ sec, $T_2=0,3$ sec, $T_3=2$ sec (Fig. 8). Thus, buildings with natural periods of vibrations close to these values are very much susceptible to heavy damages. In fact, many structures with mainly two and three storey high with periods falling into the range of $T=0.3-1$ sec., either totally collapsed or heavily damaged beyond repair in Düzce, during the Düzce Earthquake of November 12, 1999. There has been no structures in Düzce, in 1999, with a natural period close to $T_1=0.3$ sec, to have been tested by overlapping vibration as known resonance compliance period of the soil. From now on, this phenomenon stands however, as a warning to future design of building with such a long period of vibration.

The characteristics of site amplification at a given site can be attempted to be estimated by analytical methods, that models require as input the geometry of all soil layers from surface to bedrock, their dynamic properties (e.g density, wave, velocity, damping), and the incident bedrock motions. On the other hand, most reliable estimates of site amplification are obtained by analysing the record motions of site during strong earthquakes [Şafak, 2001]. One of the popular methods to estimate the site amplification had been the use of spectral ratios introduced by Borchardt [1970]. The Spectral ratio is calculated by taking the ratio of Fourier amplitude spectrum (FAS) of a soil site record to that of a reference site record. Relating with the investigating the site amplification characteristics in Duzce site, recorded motion in Duzce station during November 12, 1999 Duzce Earth Quake (EQ) is used to compute spectral ratios with respect to recorded bedrock motions during the same earthquake (Fig.9).

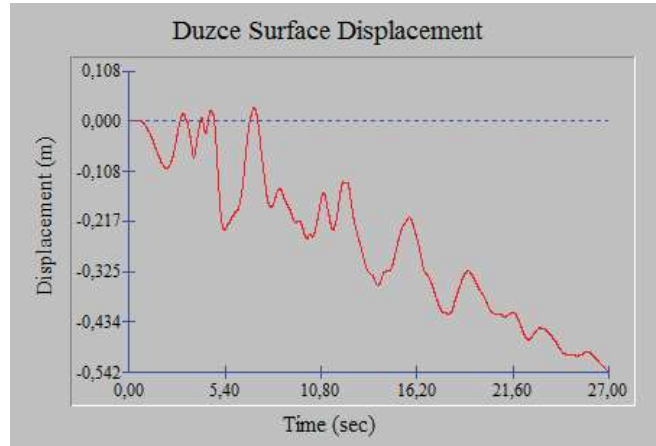
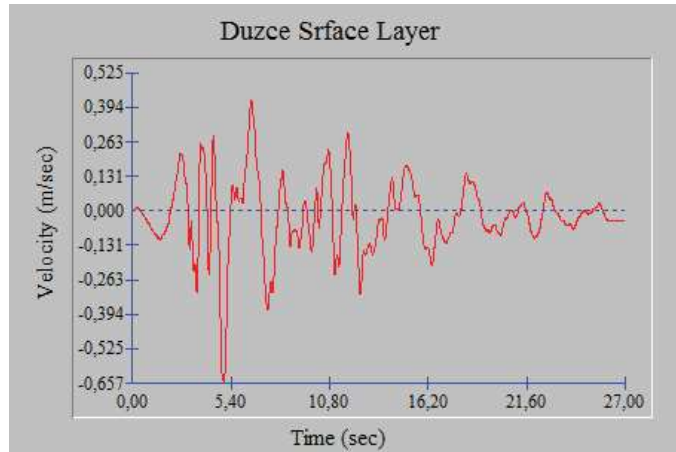
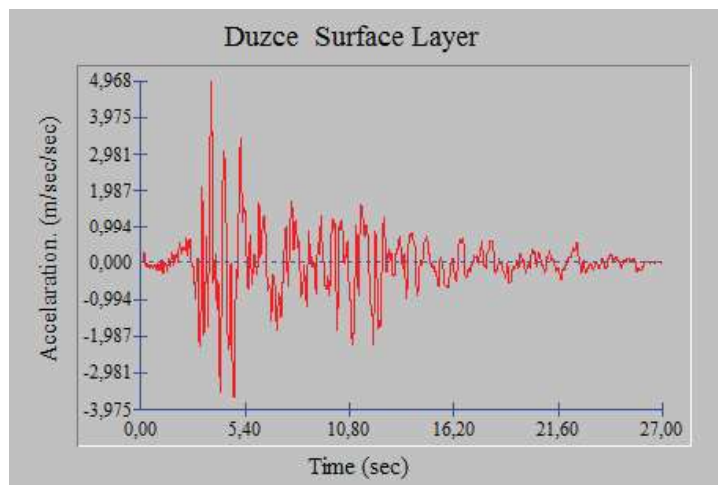
Fig.11. (a), (b), (c). Computed Site Response in Duzce METEK TOKI area

The micrometer measurements taken at the site in Duzce (METEK TOKI)also demonstrate a fundamental frequency of 1.45 Hz and is approximately consistent with the calculated frequency. According to the summary of the 1-D site response analyses results using the November 12, 1999 Duzce EQ records, the maximum values of bedrock and ground surface acceleration and spectral acceleration (based on the both recorded and computed values) determines a rather high degree of amplification at study site in Duzce, for the base rock acceleration levels of 0.4 g and 0.89 g.

For the buildings and opening residential areas in Duzce city, investigations of the site, seismic hazard studies was executed and a site specific bedrock motion was simulated for the design of the prospective earthquake ($M_w=7.2$). The design earthquake is expected to occur due to rupture of 40 km long fault segment between Efteni Lake and Bolu to be developed attending of the November 12, 1999 Duzce EQ cracking of the fault. Using this bedrock acceleration time history, 1-D analyses is performed to research the site response and to produce the earthquake parameters needed for structural analysis. The acceleration time history used as bedrock motion is in Fig. 7. With a maximum value of 0.52 g, and the computed ground surface acceleration time history is shown in (Fig. 11c). The maximum value of the computed ground surface

As can be seen from the (Figs 7,8 and 11), a peak ground acceleration value of 0.4 cm/s² occurred in the N-S direction for Duzce earthquake and 0.89 cm/s² in the E-W direction for the Duzce earthquake. It should be noted that these PGA values do not exceed the seismic hazard limit of 0.4g according to the spectra of Turkish Earthquake Code seen in (Fig.6). However, it is thought that soil amplification may occur in the study area. The computed response spectra with damping ratio of 5%, 10%, 15 % and 20% for lateral (N-S,E-W) and vertical components are given in Figs. 6 for the mentioned earthquakes. In this context, Shaking of earthquake may be most effective on buildings with natural period of up to approximately 1.5 seconds.

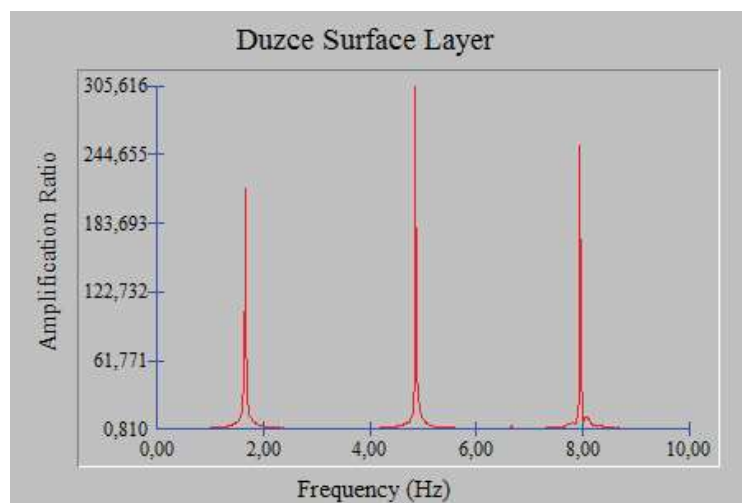
Fig. 12. Computed amplification ratio curve using simulated earthquake

The transfer function determines how each frequency in the bedrock (input) motion is amplified or deamplified by the soil layers [Firat et. al., 2015]. The variation of the amplification between ground surface and bedrock motion with respect to frequency is given in (Fig. 12), where the maximum value of amplification is obtained to be 2.1, corresponding to 1.3 Hz frequency.

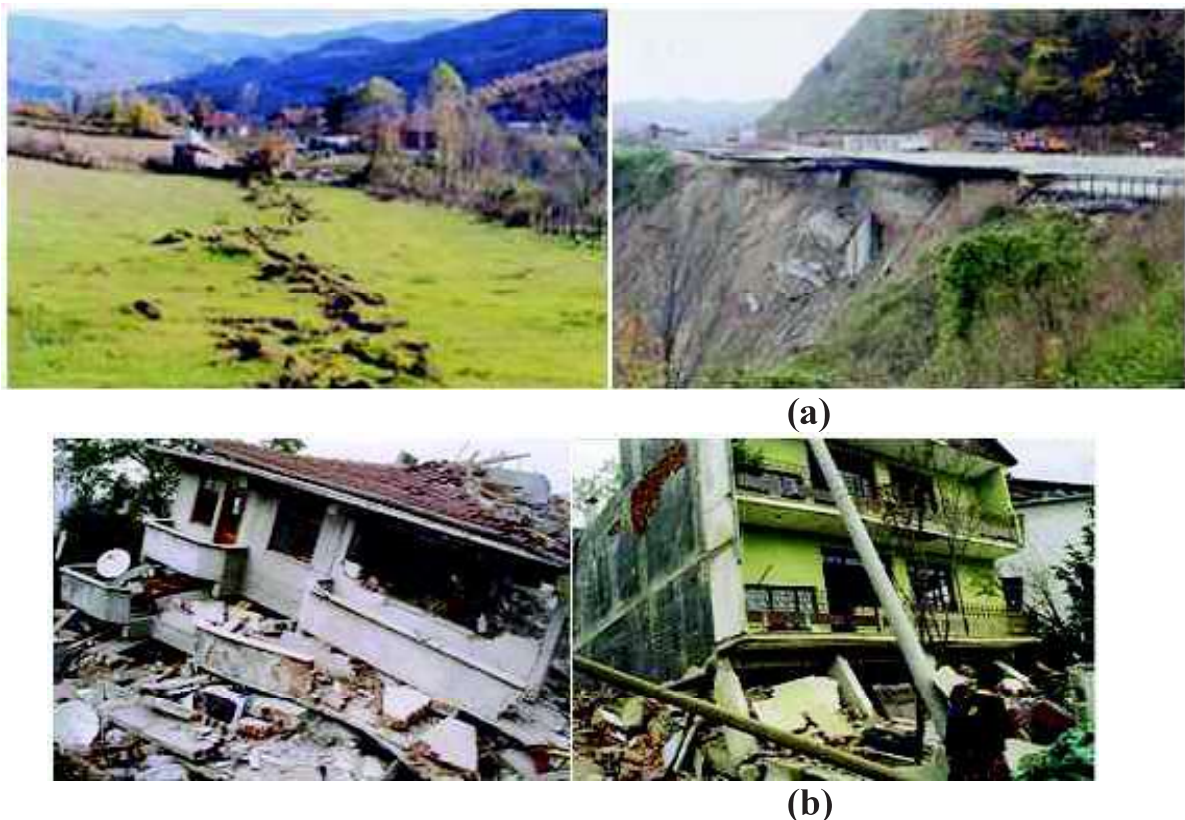
Fig. 13. Buildings was damaged, and evacuated after the 12 November 1999 Duzce EQ

The Duzce earthquake of November 12 caused significant damage to Duzce city and its environs. This earthquake struck the buildings and the majority reinforced concrete buildings were completely damaged as shown in the (Figs. 13). While designing the concrete quality is very important for the reinforced concrete structures. It was observed that the quality of concrete used was very poor and its characteristic strength in some structures in the study area was inefficient and under the level of expected strength. It was observed that some piece of concrete were crumbled from a collapsed reinforced concrete building in to dust in the study area. All these deficiencies show that the main problem at the reinforced concrete structures in the study area is poor quality of concrete. The use of low strength concrete observed in the damaged buildings were shown in (Figs.13). Separately, another source of damage which could cause weaker bond between concrete and steel bars. There are some pictures about damaged beam column joints and are given in (Fig.14). Additionally, it can be seen that confinement reinforcements were not applied at these joints correctly. Hence, the required ductility in these regions can not be supplied. Additionally, reinforcing bars in these joints are inefficient and no tie bars are presented. According to the field surveyings, the most important factor of damage in the reinforced concrete structure is presence of short lap splices and wrong end hook angle. Besides, Lack of transverse reinforcement was observed in the some damaged columns. These bars should be 90 end hooks. When the earthquake occurred, the tiebars were opened up. Special care must be given to the design of transverse reinforcement because lateral loads cause an increase in the shear force in columns, beams, structural walls and beam-column joints during earthquake [Ateş, 2015]. In sufficient replacement of transverse reinforcement was identified in some of the damaged columns. Most of the

structures were two-three storey with a heavy covering over a wooden or concrete slab skeleton (Fig. 13,14). This type of heavy covering cause the seismic demands increase. The wide spacing of bars cause in shear failures, buckling of longitudinal bars and poor confinement of the core concrete. Further more, it can be supposed that there has been another reason of the damage about inadequate column cross sectional dimensions. Another reason of damage, strong beam-weak column connections have been recognized in reinforced concrete structures which were damaged due to the Duzce earthquake 12 November 1999 (Figs. 13,14). A soft storey is a relatively flexible storey in which its relative horizontal displacement is much larger than the corresponding displacement of other stories. These floors can be especially dangerous in earthquakes because they can not be cope with the lateral forces caused by swaying of the building during an earthquake [Dönmez, 2005 and Ateş, 2015]. Presence of soft storey results in increased deformation demands significantly, and puts the burden of energy dissipation on the storey columns. Many failures and collapses can be attributed to the increased deformation demands caused by soft stories as well as the lack of deformability of poorly designed columns. Thus, any sudden changes in the lateral stiffness and strength must be avoided. Soft storey buildings are characterized by having a storey with too much open space [Dönmez, 2005 and Ateş, 2015].
