## THE ROLE OF GEOPHYSICAL ERT METHOD TO EVALUATE THE LEAKPROOFNESS OF DIAPHRAGM WALL OF DEEP FOUNDATION TRENCHES ON THE EXAMPLE OF THE CONSTRUCTION OF RETAIL AND OFFICE COMPLEX IN LUBLIN, POLAND

This paper addresses the problem of assessing the leakproofness of the bottom of a deep foundation trench, secured by cavity wall, using geophysical methods of electrical resistivity tomography. The study was conducted on a large construction project in Lublin, in a place where there are complicated soil-water conditions: the groundwater level is above the proposed depth of foundation trench, the subsoil is heterogeneous, and there are karsted and weathered carbonate sediments with confined aquifer below the bottom of the trench. A hydraulic fracture occurred at the bottom of the trench during the engineering works, which caused the water flow into the trench. In order to recognize the soil-water conditions the first stage of geophysical measurements of electrical resistivity tomography (ERT) was made. The applied methodology allowed to determine the extent of the hydraulic fracture zone within the bottom of foundation trench. In order to assess the leakproofness of Diaphragm Wall the geo

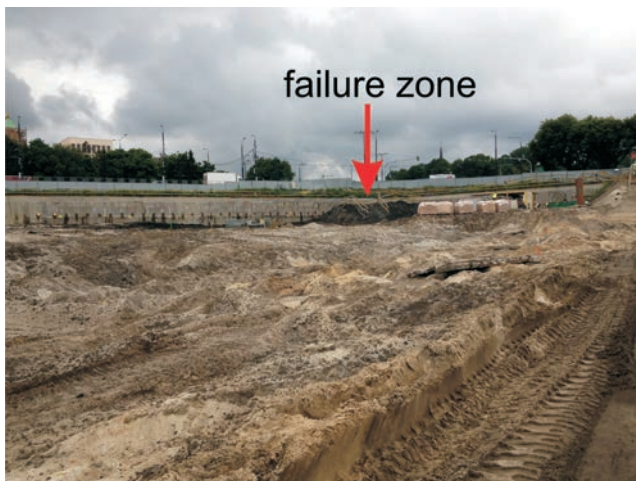
**Fig. 1.** View of the NW part of the foundation trench.

In 2012, giant office and service complex started to be built in Lublin (south-eastern part of Poland). The area of deep excavation was approximately 2.5 ha (Fig. 1). Location of the investment is shown in Fig. 2.

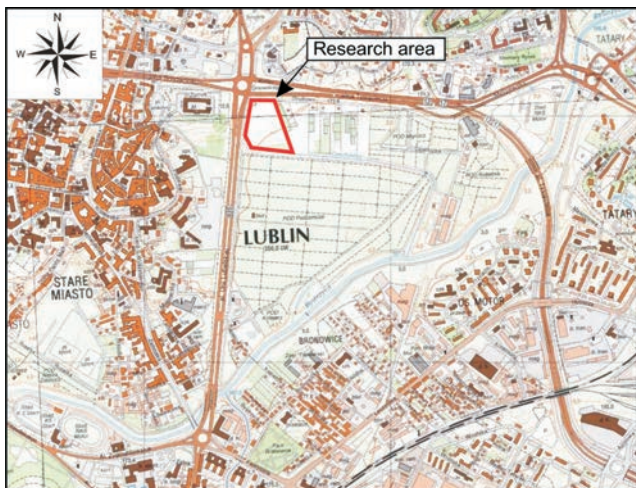
**Fig. 2.** Location of the ERT geophysical research area.

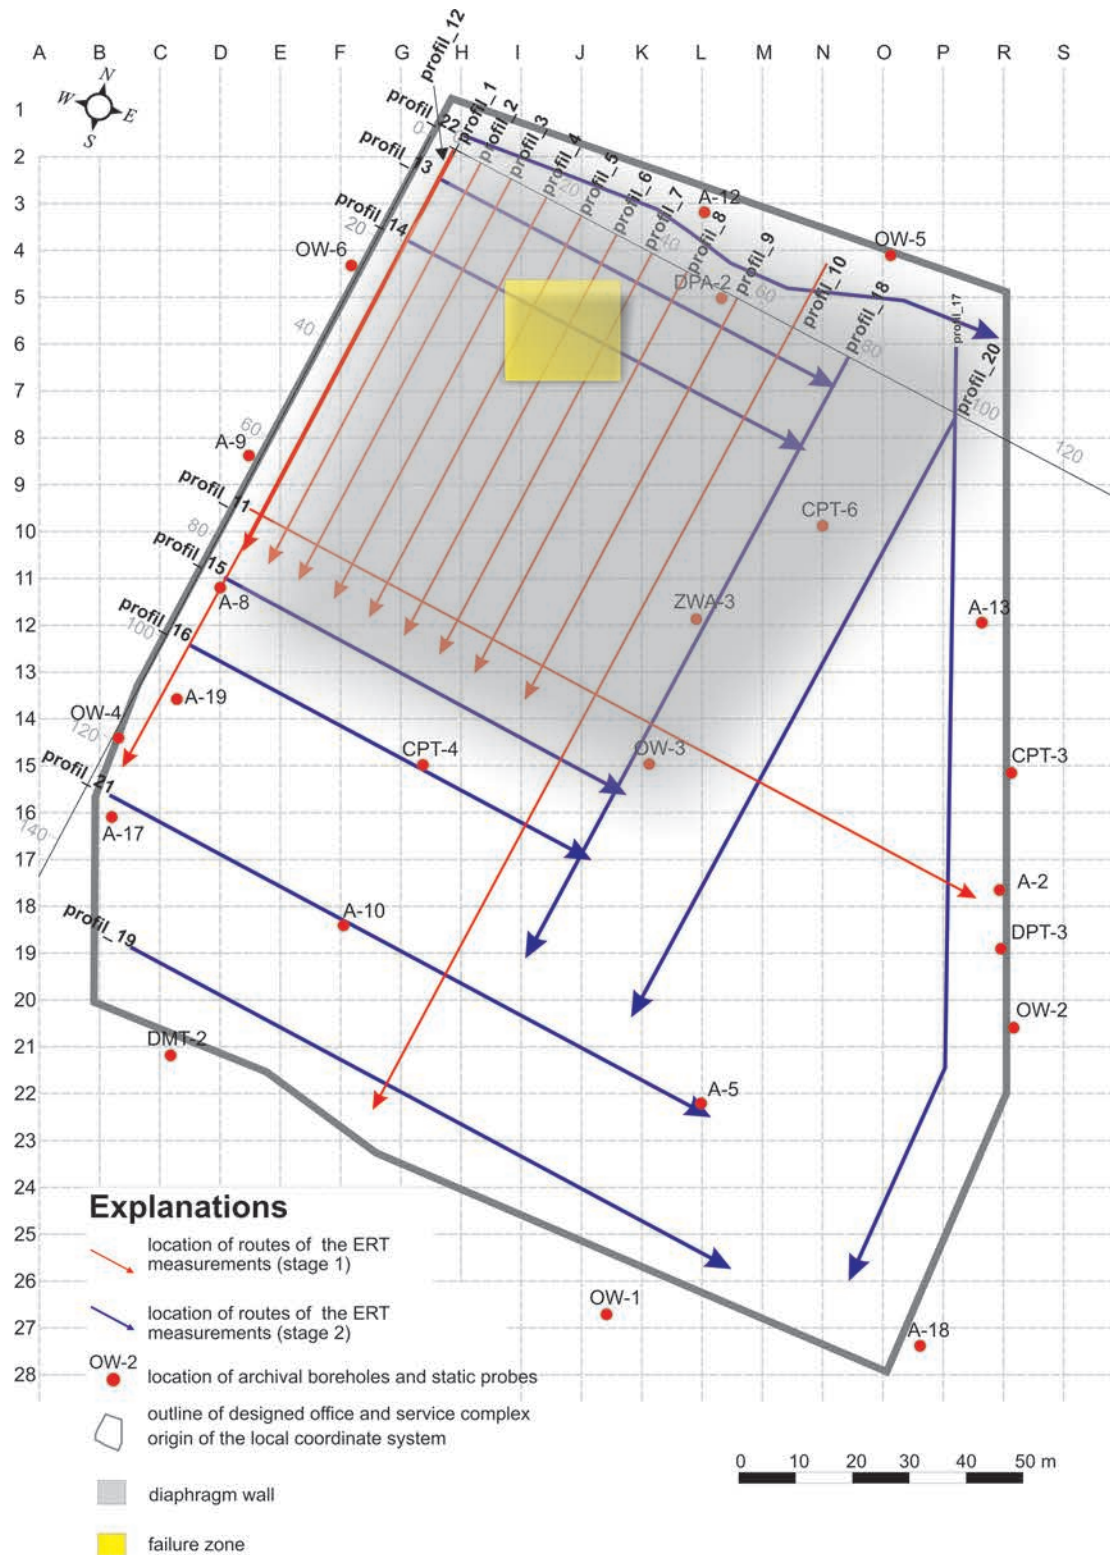
**Fig. 5.** Documentary map of ERT measurements.

The location of measurement profiles are shown in Fig. 5. The fracture zone is situated in the NW part of the trench (Fig. 5).
