Living Outside the Wall: the Quarter of Wattle-and-daub Houses in Old Dongola of the Funj Period

Maciej Wyzgot

Agata Deptuła

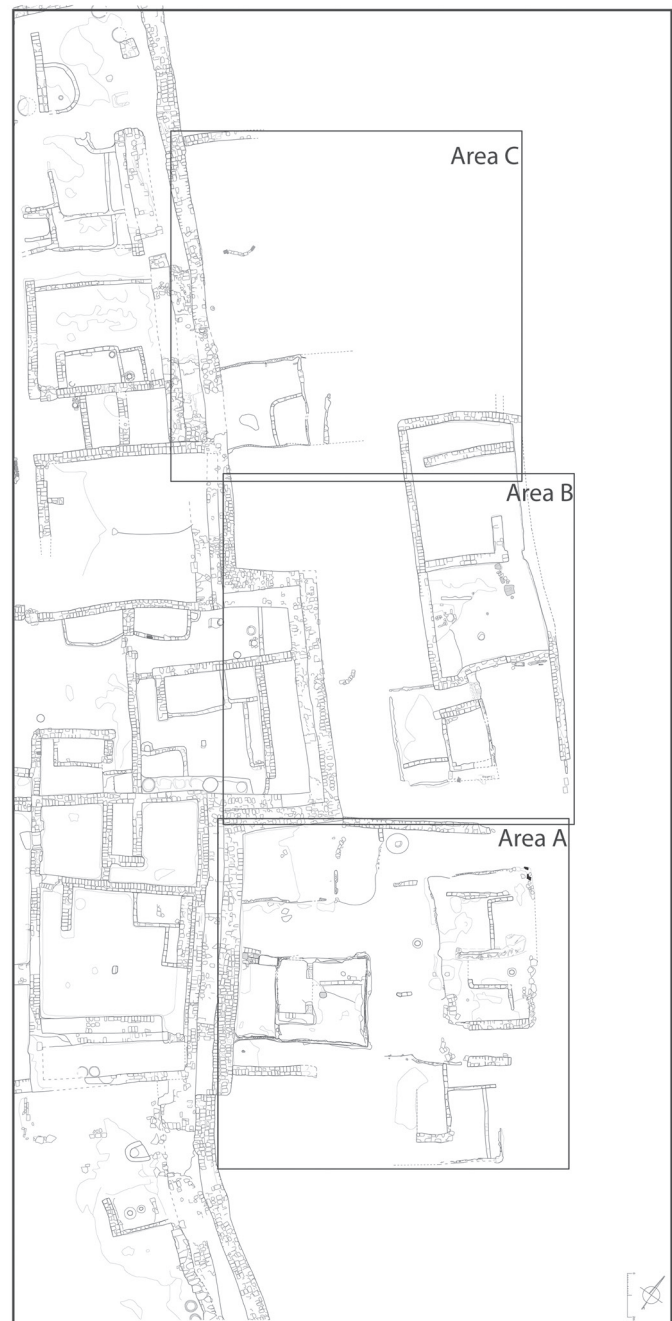
FIGURE 4 The areas A, B and C.
DRAWING BY AGNIESZKA WUJEC

Area A is located in the south-eastern part of the quarter. It was excavated to the earliest phase recorded so far, not reached in other areas of the town quarter under consideration. It functioned until the last phase of occupation recorded in this part of the town.

Area B is located in the central part of the quarter. It was excavated to a level following the earliest phase recorded in area A. It consisted of only one house, related either to the houses in area A or in area C.

Area C is located in the north-western part of the quarter. The houses in this part are poorly preserved, but it is possible to determine that the last phase exposed there comprised the latest houses in the district. The area was excavated to a level contemporary to the house in area B.

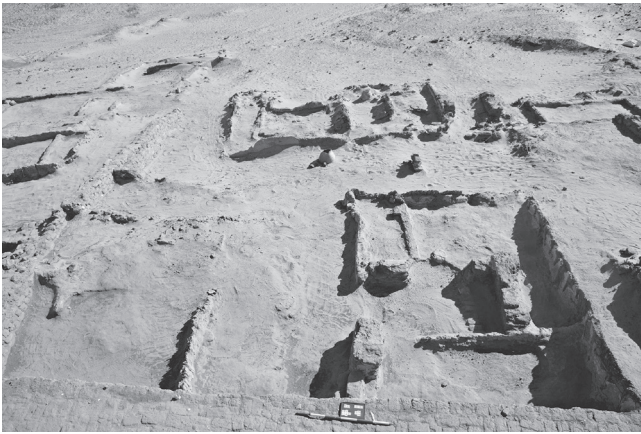
FIGURE 8 Houses in the area A during the 2nd phase.
PHOTOGRAPH BY MATEUSZ REKLAJTIS

At approximately the same time, building U29 was added in the corner of the town walls (Figs. 7, 8). The building comprised only one space with no traces of furnishings. The only distinctive features are the consecutive floor layers made of tamped refuse with a substantial admixture of ashes and an abundant accumulation of ashes in the corner of the building. It is not clear where the original entrance to the building was located. A threshold connected with the latest phase overlay the town wall that delimited the house from the north. This implies that

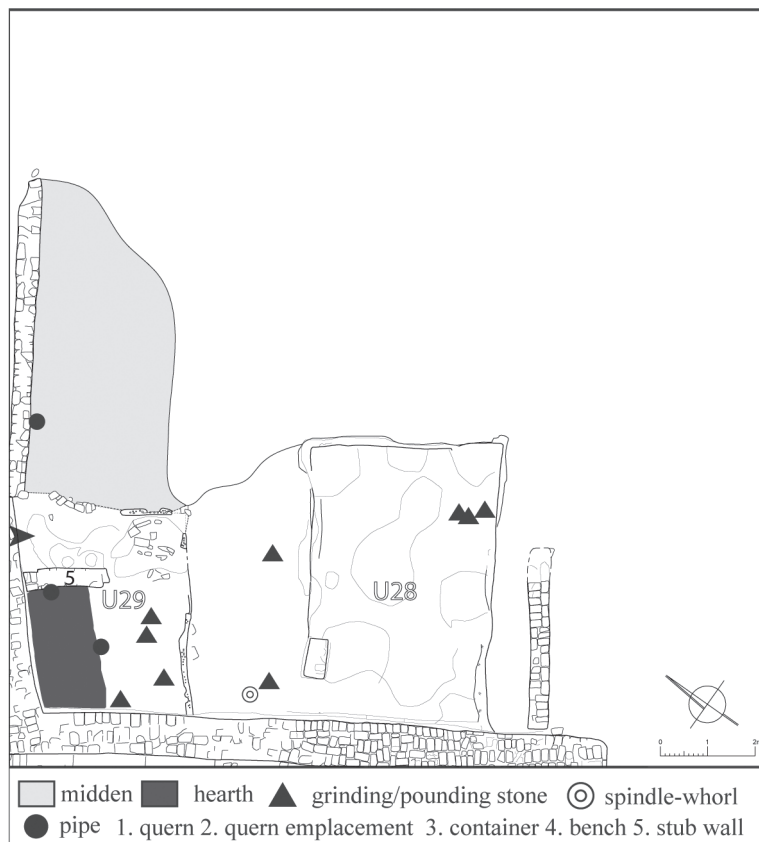
FIGURE 10

Plan of the area A in the 3rd phase.

was constituted by tamped and levelled layers of debris from the collapsed walls of U28a/28b (Fig. 10). No structures are preserved, nor are there artefacts indicating any specific activity that took place within this area. Still, it may be assumed that the area remained a place of sporadic human activity as indicated by the accumulation of anthropogenic deposits interspersed with isolated bonfires and small finds, amongst which a magical ostrakon (inv. no. 44) with Arabic inscriptions on both sides is especially remarkable.

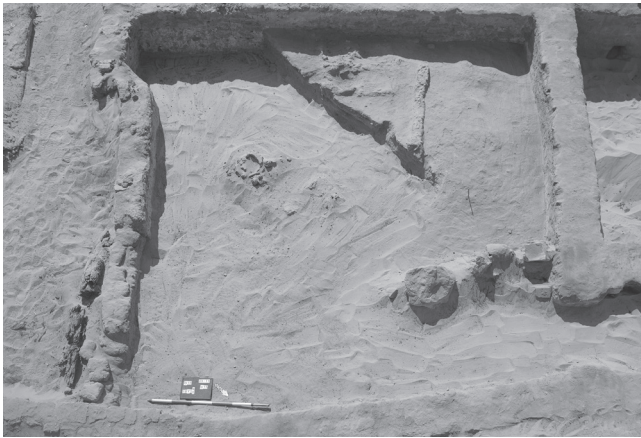
FIGURE 13 Unit 15.
PHOTOGRAPH BY MATEUSZ REKLAJTIS

The compound of the house U37 comprises three distinct areas. U37, equipped with two sun-dried brick benches located behind a stub wall, appears to have been the primary dwelling space. This interpretation is corroborated by visibility analysis, which shows that the benches are not visible from the outside as a result of construction of the stub wall (Fig. 11a). The lack of any traces of activities and occupational layers suggests that this area was used
