APPLYING THE ISHIKAWA DIAGRAM IN THE PROCESS OF IMPROVING THE PRODUCTION OF DRIVE HALF-SHAFTS

The company that will be presented in this analysis produces half-shafts for various types of cars and constantly analyzes, verifies, and undertakes corrective and preventative action to remedy the occurring inconsistencies. For this purpose, the company uses, among other means, various quality tools. The object of the following research is the application of the Ishikawa diagram in the process of improving the half-shaft production.

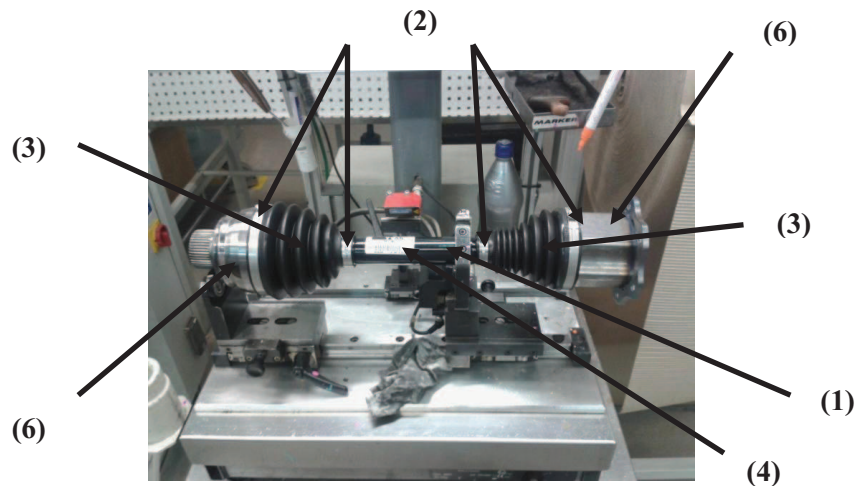
The figure number one (Figure 2.1) shows an example of front drive half-shaft : (1) produced in the studied company, which consists of the

following components: (2) band / bands, (3) housing, under which a sufficient amount of grease can be found, (4) labels, (5) joint located on the wheel's side, and (6) tulip. The left side of the drive half-shaft is located on the wheel's side, while the right side is located on the gearbox' side. Preliminary analysis of the production process showed that a falling band located on the side of the wheel causes the problem. The problem occurred at the work stand of the first assembly line operator (Figure 2.2).

Fig. 2.1. Example of the front drive half-shaft.
