# The Vistula Canal, the state after 120 years of activity

**Abstract:** During the catastrophic flood caused by the ice dam in 1840, a new river mouth was created. Nevertheless some series of floods were observed in the next years. In order to facilitate of river waters run-off, the artificial crosscut was performed in 1891-1895 years. The artificial channel was opened in 31st of March 1895. Since, at the time of continuous exploitation of the channel, high effectiveness of the engineering project which is unique in the world scale has been confirmed. A permanent flood hazard for Gdansk city and adjacent lowland areas has been receded. Since this time, the external delta is being formed by accumulation of bed-loaded sediment that is transporting by the river. Consequently free run-off of the river water is reducing due to the external delta growing.

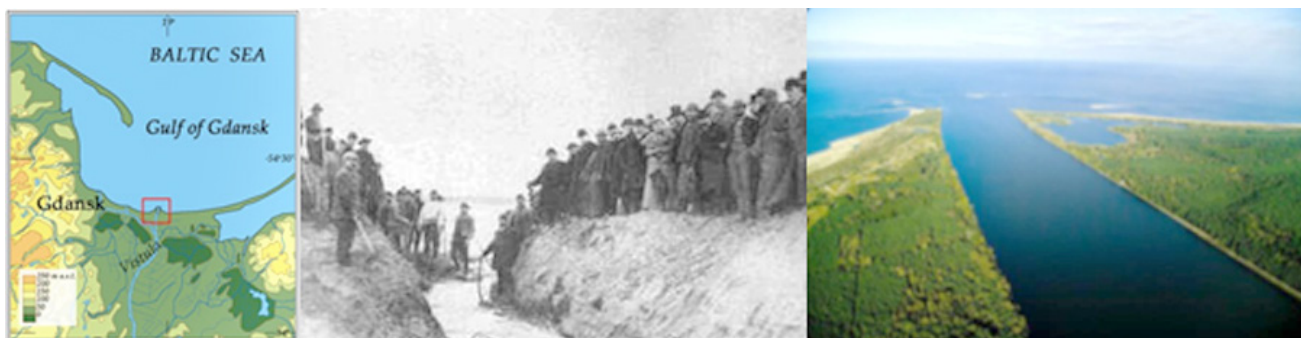
Fig. 1. MLocation of the study area (on the left). Historical photo of the Vistula River artificial channel opening ceremony in 31 of March 1895 (in the middle; source of the photo: www.zulawy.info). Present-day photo of the Vistula River mouth channel (on the right; source of the photo: www.visitzulawy.pl).

in the main Vistula River mouth area located in Polish coastal waters (Fig. 1). An area of the interest was mapped using boat-mounted high-resolution Reson SeaBat 7101 multi-beam echosounder (MBES) operating at 240 kHz and additionally – with using of Dezo 15 single-beam echosounder (SBES) operating at 200 kHz in areas shallower than 4 [m]. The sound velocity probe Reson SVP-70 was fixed to the MBES head, and the portable sound velocity profiler Reson SVP-15 were used to obtain the sound speed on the depth of the MBES draft and in the whole water column, respectively. The positioning system DGPS RTK Trimble SPS 851 together with Ixsea Hydrins inertial navigational system were integrated with MBES (or SBES) using the QINSy data acquisition software package. Based on operational data acquired in the internet information service of the Polish Institute of Meteorology and Management (www.pogodynka.

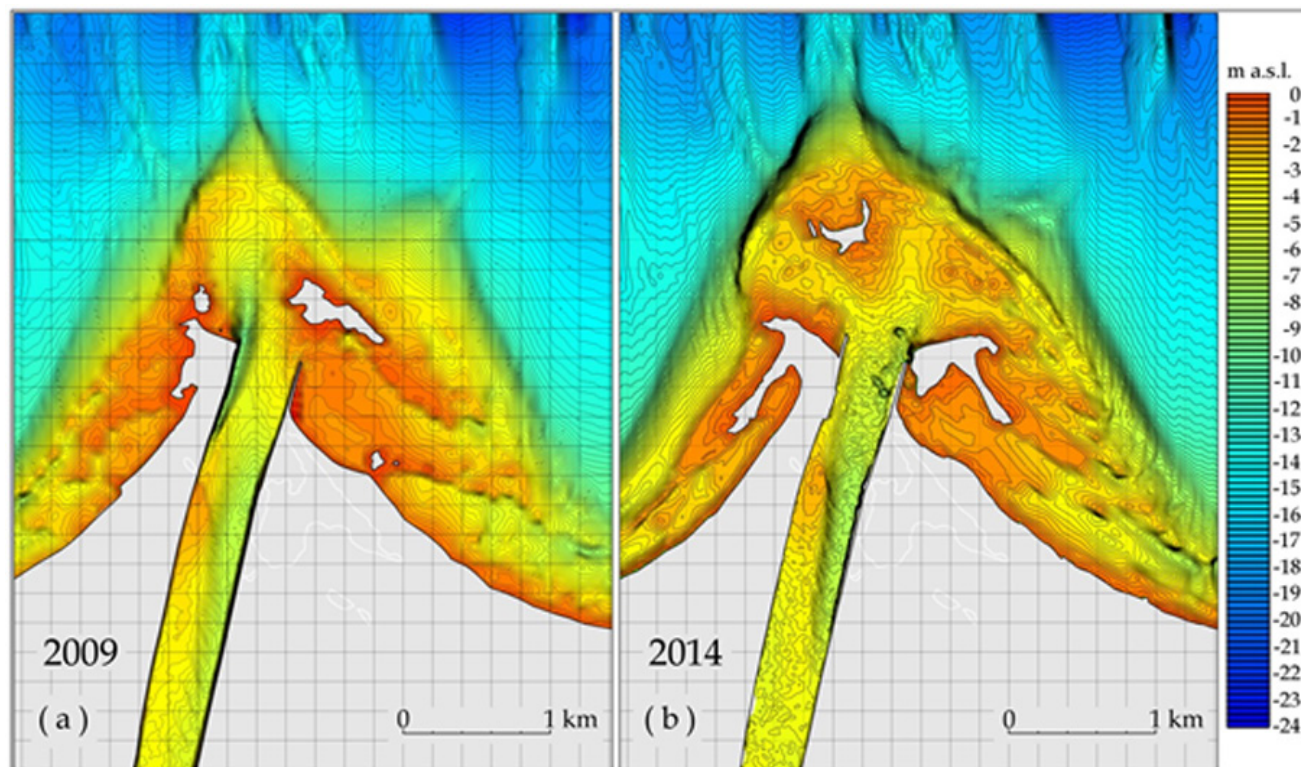
Fig. 2. Bathymetric maps of the Vistula River mouth area based on data obtained in measurement campaigns performed in August 2009 (a) and October 2014 (b). Colorbar scale in meters.

For individual states, digital terrain model (DTM) of the bed surface was obtained from echosounder's data. The bathymetric data were gridded with a cell size of 2.5 [m]. The relief image and bathymetric map (isobaths interval of 0.25 [m]) were elaborated. These formed a basis for a compilation of geomorphological and differential maps (Wróblewski *et al.* 2015).

The detailed bathymetrical maps (Fig. 2) were executed within the Vistula River Mouth area, where main geomorphological units as supply and distributary channels, delta plain, delta front and prodelta were highlighted. The bottom relief of the supply channel consists of two biggest forms – sand bar and trough, located along the border of the channel. As in the previous study (Lisimenka *et al.*, 2013), the occurrence of multiple generations of small to large subaqueous dunes, both two- and three-dimensional of various orientations, whose asymmetries indicate a general seaward migration, was observed. There are a couple generations of bars, shoals and efemerical islands on the area of the delta plain with a depth up to about 5 [m]. The front of the delta descends with a steep slope to the depths of about 12-13 [m]. The prodelta with depth up to about 17 [m] is characterized by a mild seaward inclination and contains elongated, ovoid, fingerlike formed tongues of a faraway deposited bedload.
