State of shore and backshore on the basis of monitoring results for selected polish seashores

H. Boniecka, A. Kaźmierczak, H. Boniecka, A. Kaźmierczak

The Maritime Institute in Gdańsk, The Department of Maritime Hydrotechnics
Instytut Morski, Zakład Hydrotechniki Morskiej Długi Targ 41/42, 80-830 Gdańsk

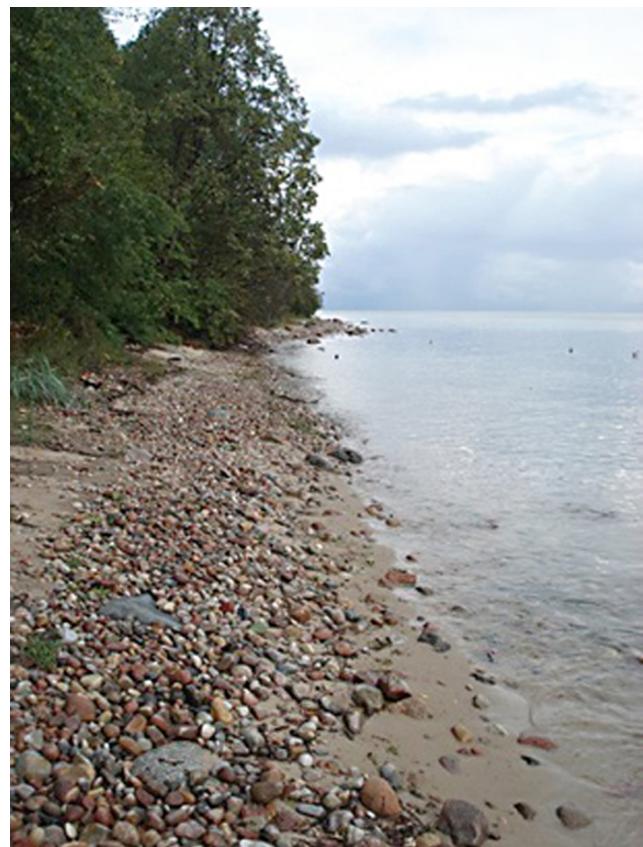
Fig. 1. Pebble beach in the region of the Kępa Oksywaska (Obłuże) cliff
(photograph by Boniecka, 2006).

Beaches consist of loose mineral grains, primarily of sandy fraction, usually quartz, and comparatively well rounded. There occur, however, also beaches made of much coarser material qualified as boulder fraction. This applies to the sections where rubble gets washed from the moraine eleva-

tions and the formed abrasive platforms undercut by the sea (Photos 1–3/Fot. 1-3). Dunes are accumulative forms of an unambiguous aeolian origin, taking a form of sandy hills of a parabolic shape. Basically, they are reservoirs of sand ensuring balance in the beach zone. In the winter season, dunes are eroded, whereas in the summer, the excess of beach sand is included into the area of the dune strip. Frontal dunes are a morphological type peculiar to the coastal areas. They are long, low (up to 3–4 m tall) embankments spreading parallel to the shoreline. Their formation is favored by plants that keep the sand, thus forming banks, which are next colonized by vegetation and stabilized. On their outer side there may form parallel strips of frontal dunes. During the storms, the frontal dunes may undergo total, or partial erosion [1; 2; 4; 15] (see Photos 4-5/Fot. 4-5).

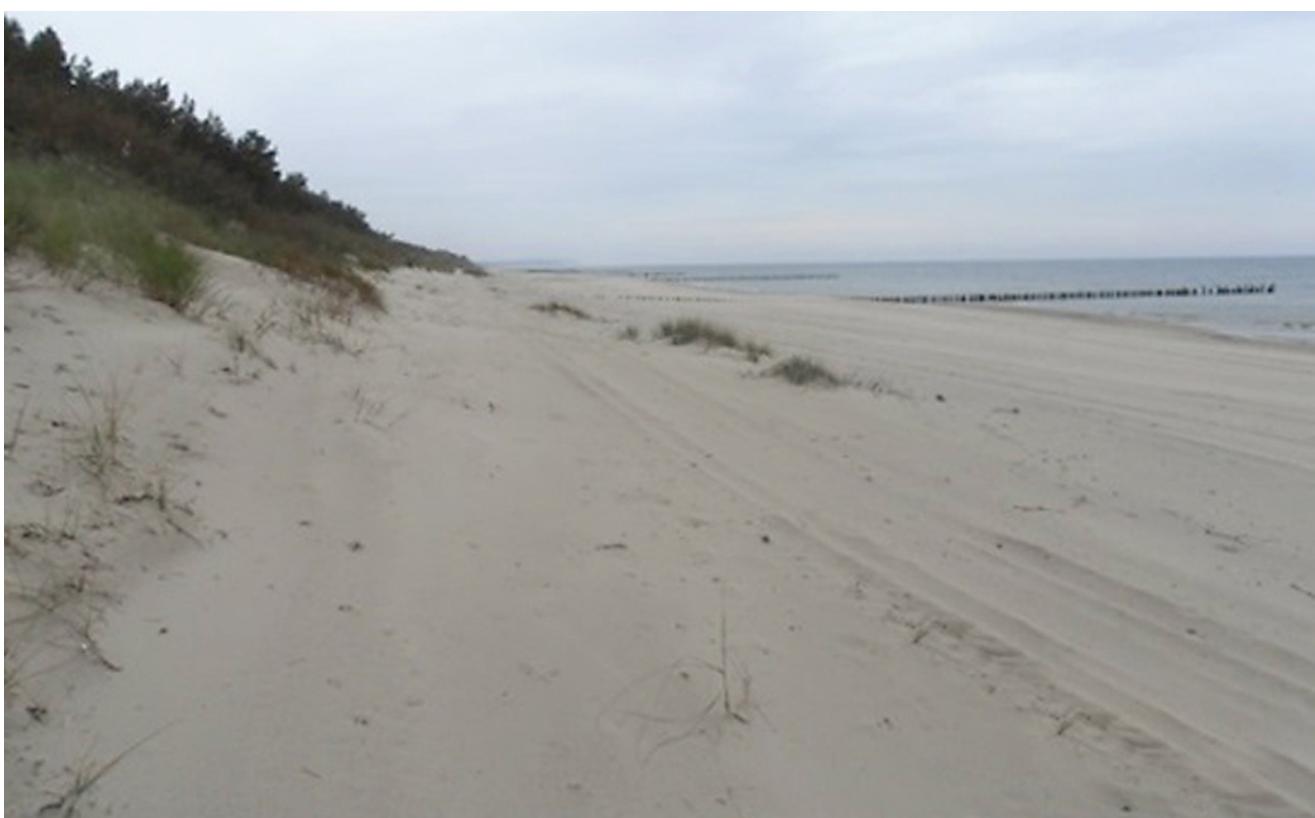
Fig. 2. Sandy beaches near Międzywodzie (photograph by Boniecka, 2014).

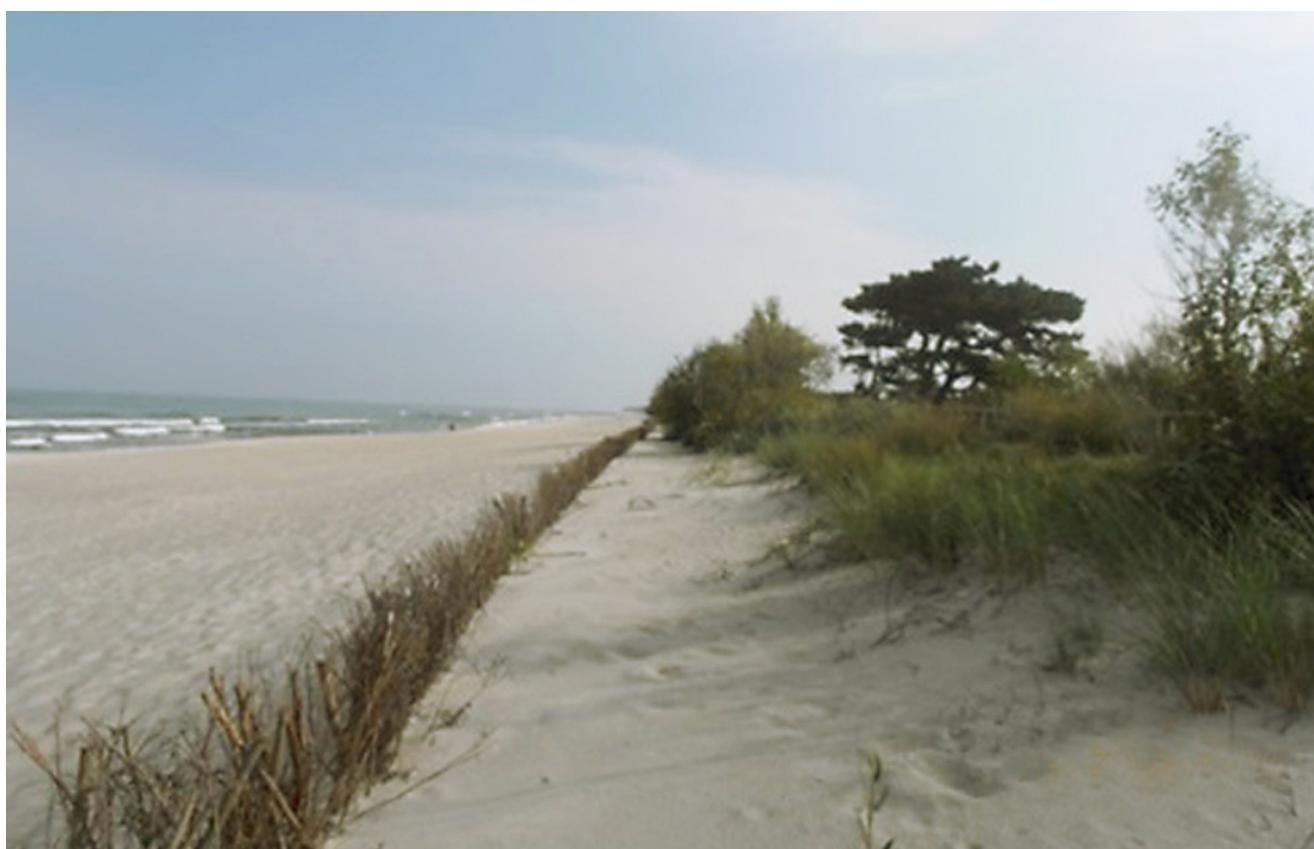
Fig. 3. Sandy beach, refilled on the Hel Peninsula (photograph by Boniecka, 2012).

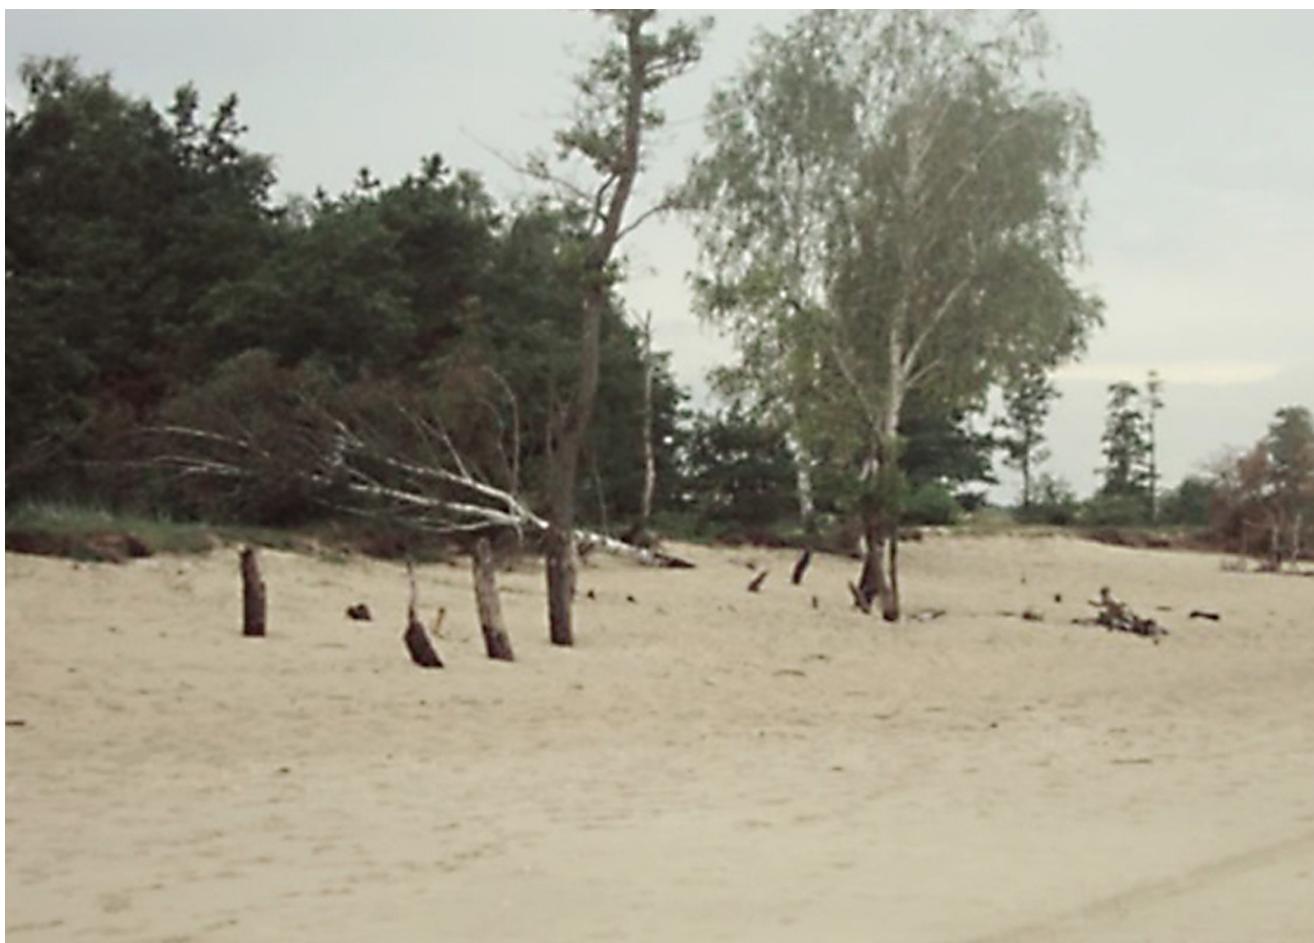
Fig. 4. A devastated dune to the east of "Ptasi Raj" bird sanctuary (photograph by Boniecka, 2012).

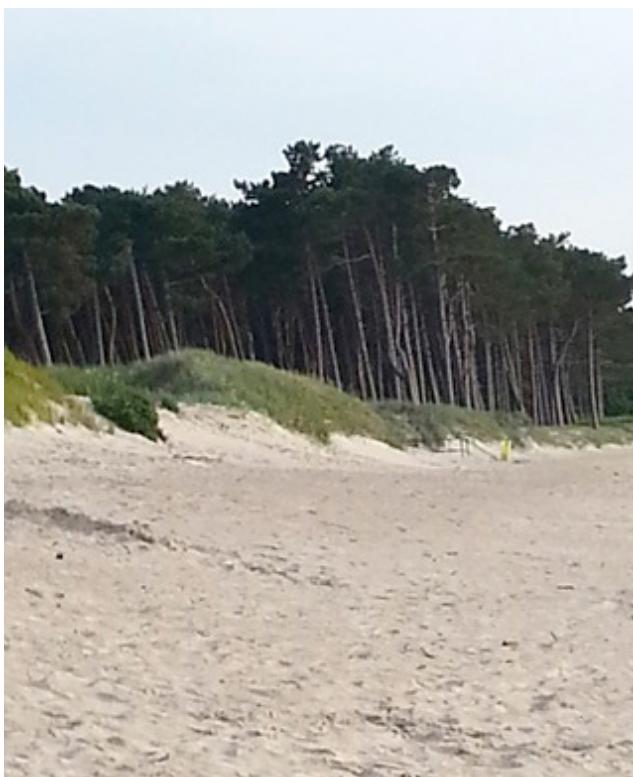
Fig. 5. Dune shore in the neighborhood of Darłowo (photograph by Boniecka, 2015).

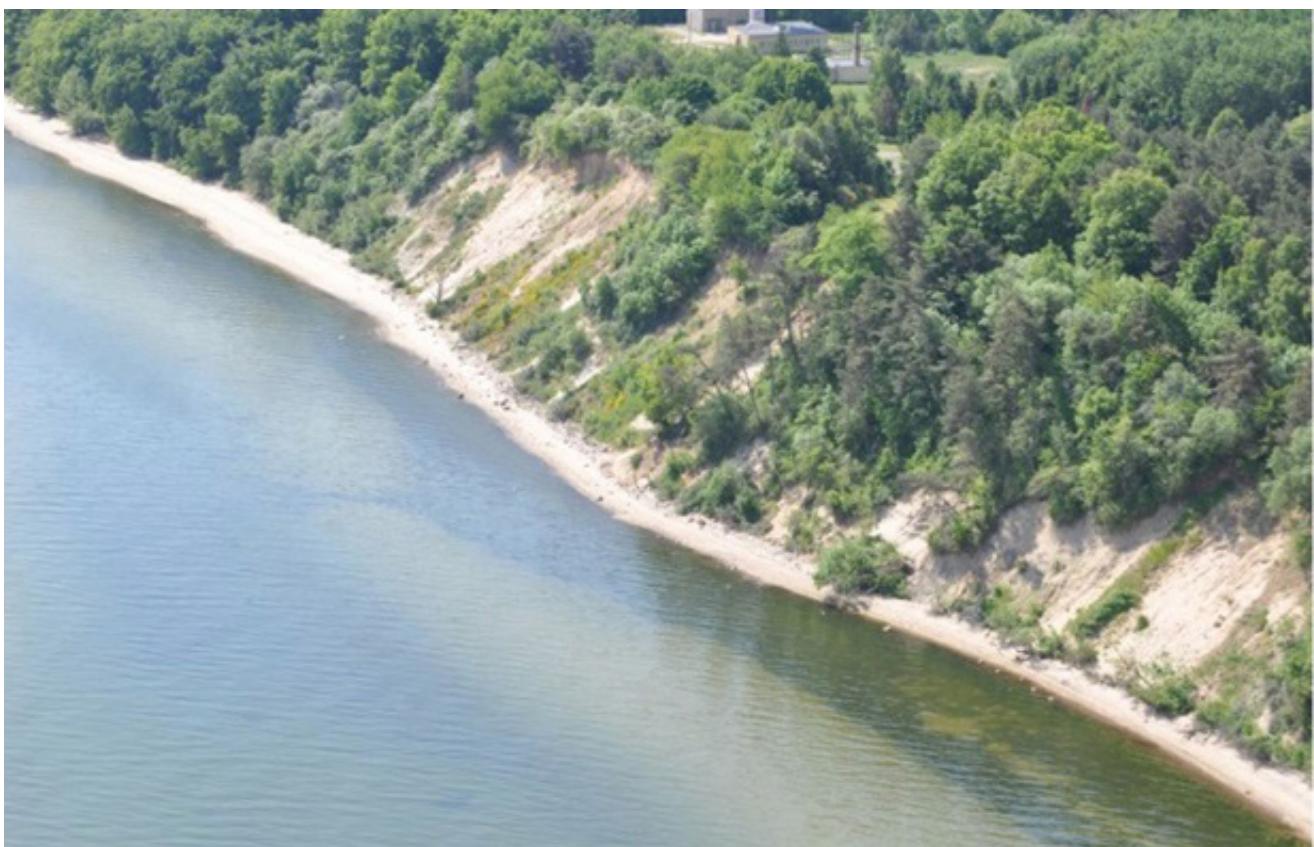
Fig. 6. The Mechelinki Cliff (photograph by Domaradzki, 2013).

face processes. To the later ones, there belongs first of all the mass wasting, aided by the cliff's being constantly undercut by waves. It leads to an increase in the slope's steepness, and a loss of its stability. Depending on features of the bedrock, cliff coastlines are transformed by tearing and coming off of the fragments, deep rotational landslides, runoffs, and mudslides. The released rocky material piles up at the foot of the cliff, from where it gets washed away by waves and coastal currents. Thus, the cliff's base gets exposed again, leading to another episodes of mass wasting, and shifting of the cliff's crest, and sometimes even of the shore further inland [5], (see Photos 6-7/Fot. 6-7).

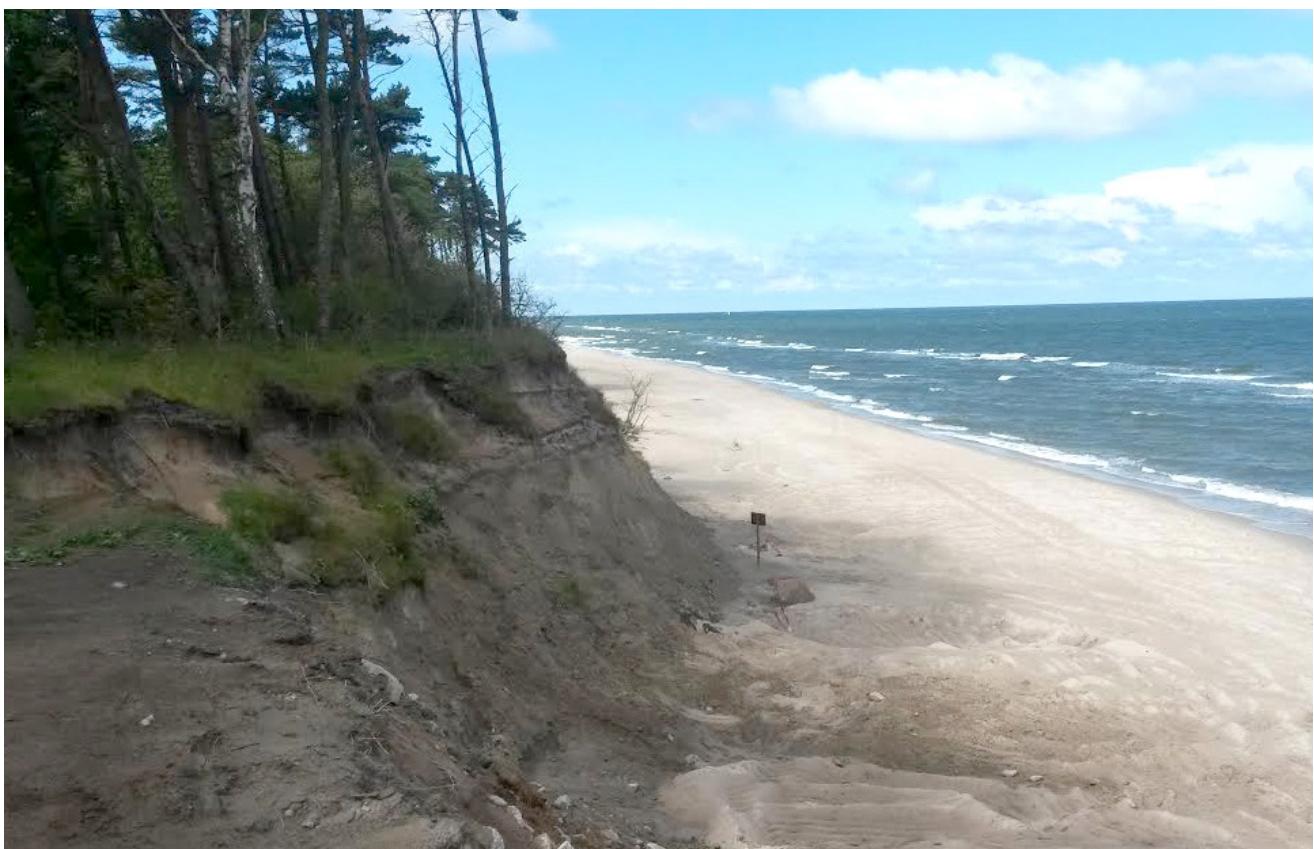
Fig. 7. Cliff coast in the neighborhood of Niechorze (photograph by Boniecka, 2014).
